C-276

CASE HISTORY

Hydrated Lime Feeding for Water Treatment at Gold King Mine

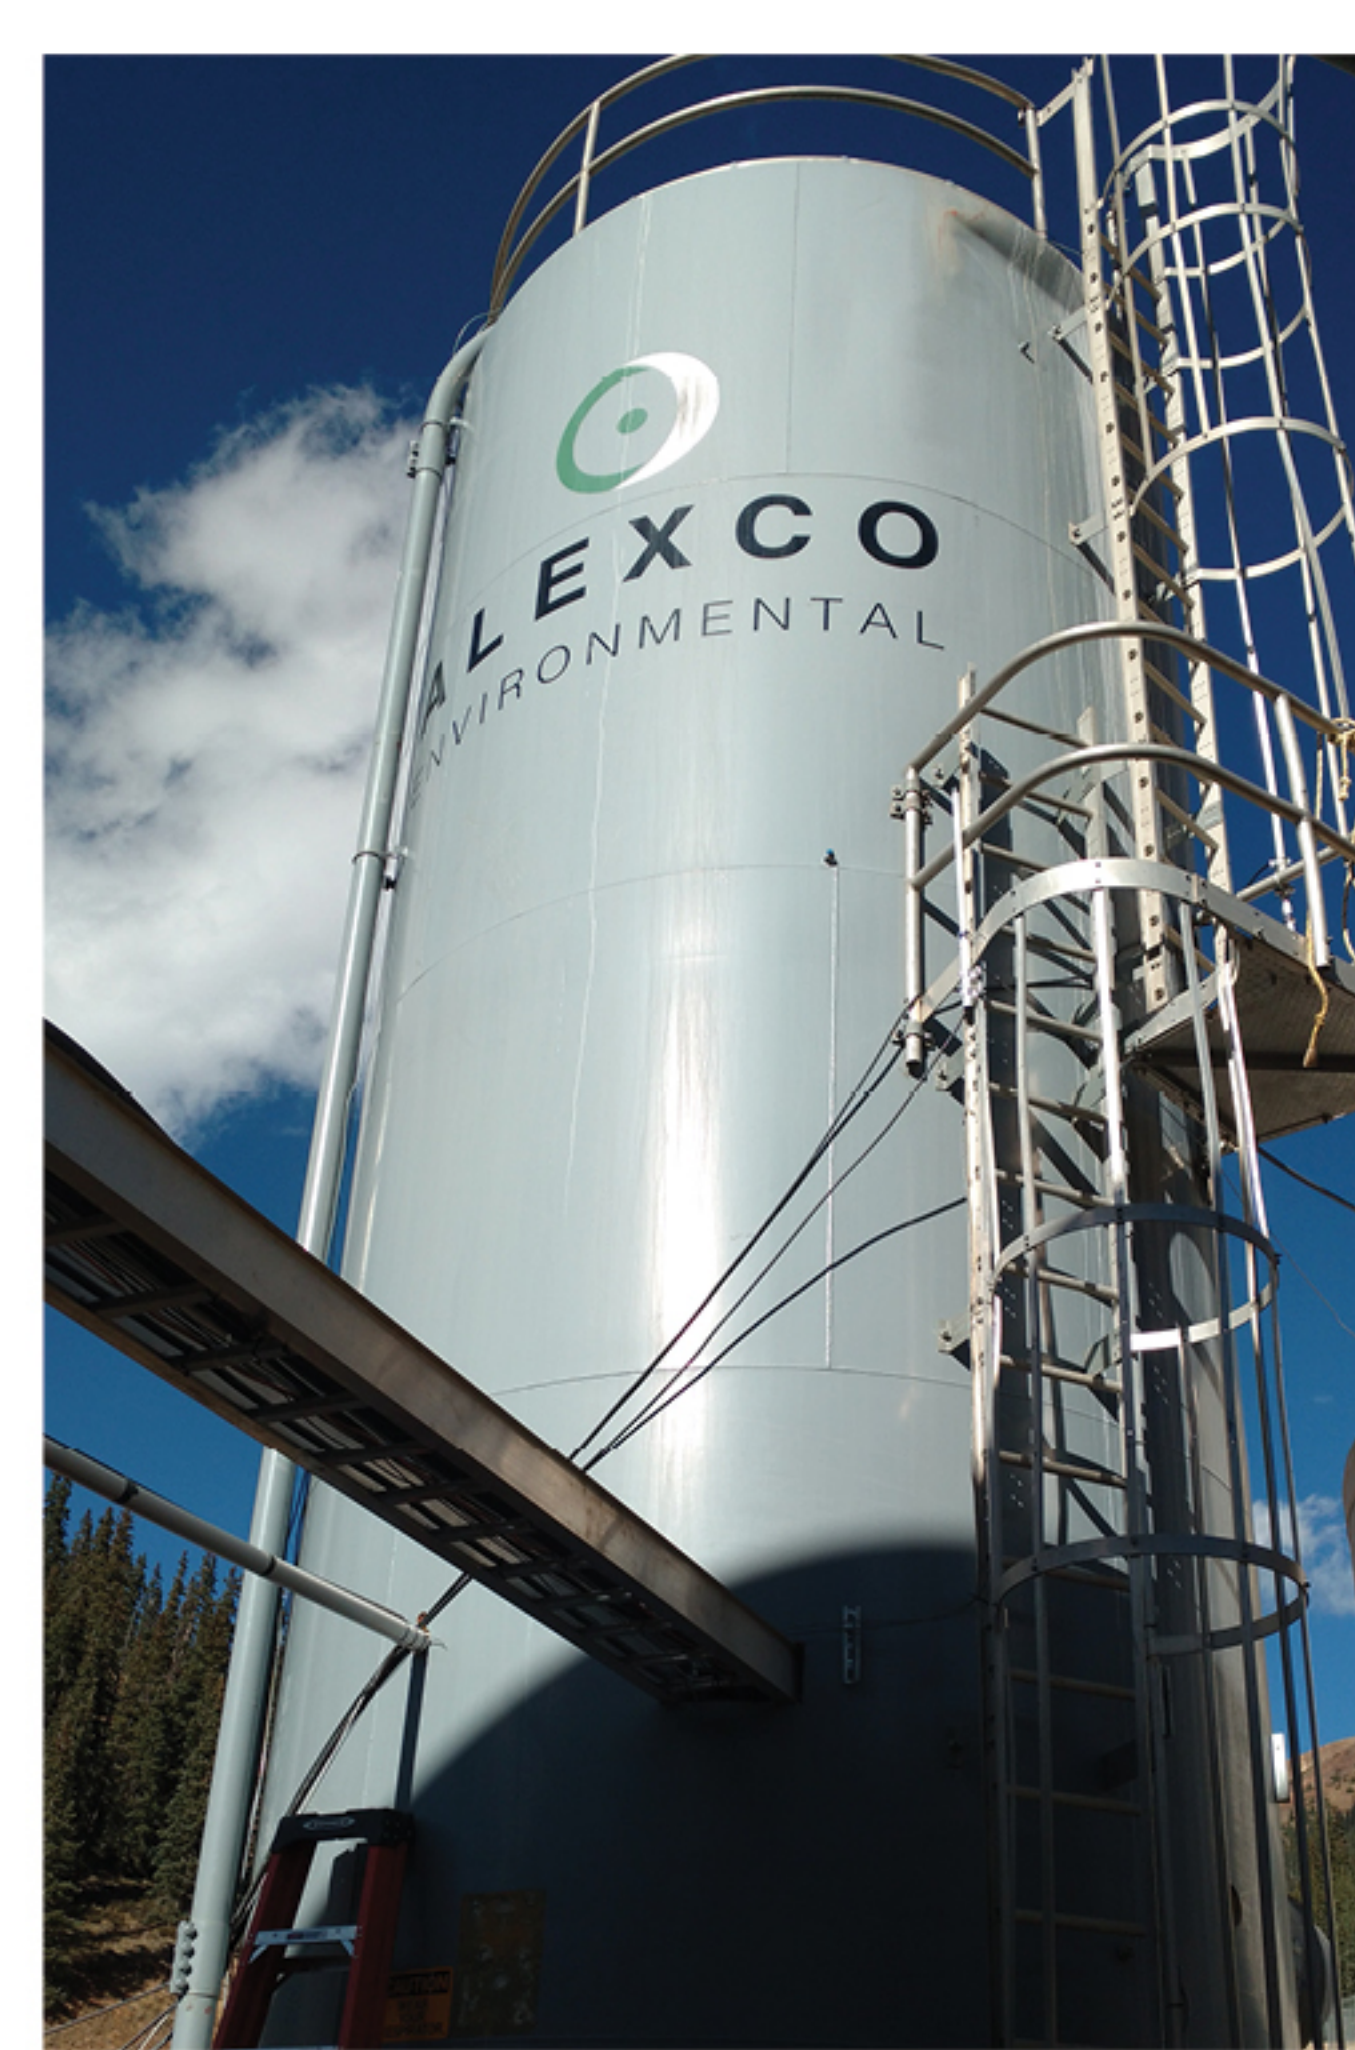
The AccuFeed was placed below the silo which provided the bulk lime supply. Feeder discharge was to the influent feed line. Treatment includes all flow from the mine as well as water that had been stored in the retention ponds.

The feeder uses a patented controlled vibration design to ensure even filling of its feed screw with uniformly dense material. This provides for extremely high feed accuracies. The feeder is molded from high strength, composite materials that provide a high degree of corrosion resistance.
